Manhole Inspection Summary

Manhole # S23A__018MH

Location Address: **710 ALLEYCALHOUN-CAREY**

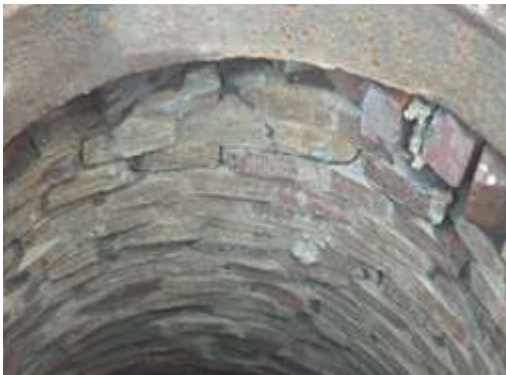
Defect 3

Condition: ☐ Sound ☒ **Cracked** ☐ Root Intrusion ☐ Loose Brick ☐ Deteriorated

Infiltration: ☐ None ☐ Joint ☐ Cracks ☐ Mortar ☐ Roots ☒ **Wall**

CRACKED CORBEL

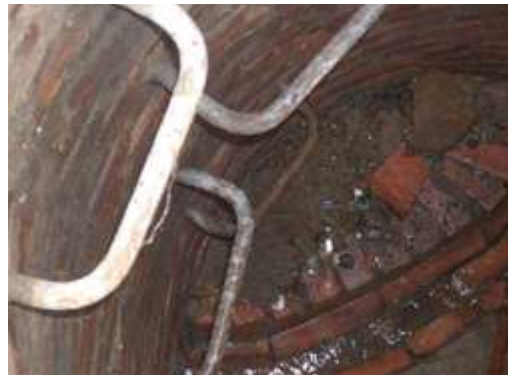
Defect 2

Count: **4** Missing: **0** ☒ **Corroded**

CORRODED STEPS

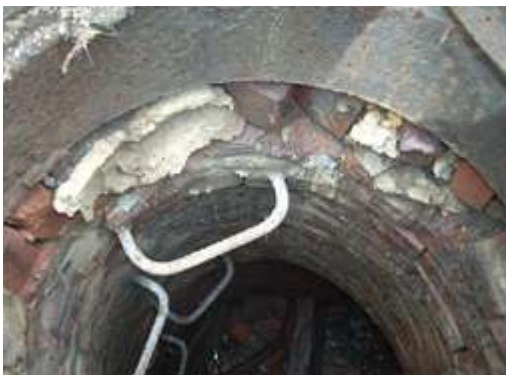
Defect 1

Condition: ☐ Sound ☐ Cracked ☐ Root Intrusion ☐ Loose Brick ☒ **Deteriorated**

DETERIORATION OF CHIMNEY

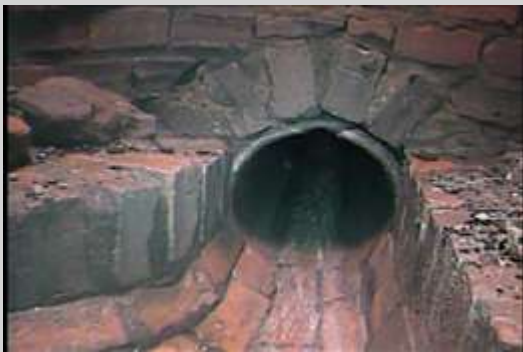
12 O'Clock Outflow

Pipe Height: **8.4** (in.) Rod and Bar (Angled)
Pipe Material: **Clay** ☐ Pipe Lined
Invert Depth: **8.91** (ft.) Flow Characteristics: **Fast**
Deposits: ☒ None ☐ Mud ☐ Sludge ☐ Debris ☐ Grease
Silt Depth: (in.) Deposits Extent:
Infiltration: **None** Pipe Seal Cond: **Sound**

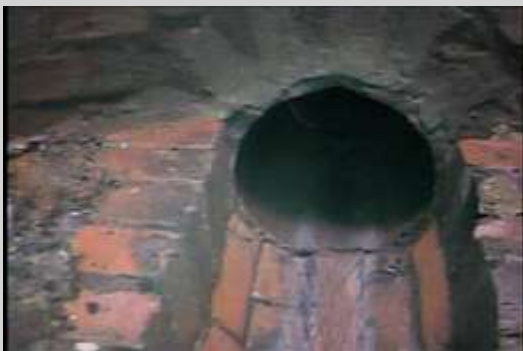
6 O'Clock Inflow

Pipe Height: **7.2** (in.) Rod and Bar (Angled)
Pipe Material: **Clay** ☐ Pipe Lined
Invert Depth: **8.42** (ft.) Flow Characteristics: **Fast**
Deposits: ☒ None ☐ Mud ☐ Sludge ☐ Debris ☐ Grease
Silt Depth: (in.) Deposits Extent:
Infiltration: **None** Pipe Seal Cond: **Sound**

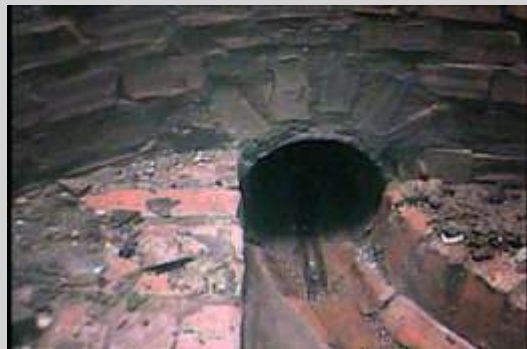
9 O'Clock Inflow

Pipe Height: **8.4** (in.) Rod and Bar (Angled)

Infiltration: **None** Pipe Seal Cond: **Sound**
